A new approach to minimally invasive preparation of a crack line on the labial surface of an anterior tooth: A case report

Hidetaka Ishizaki* and Takashi Matsuura**

Department of Periodontology and Endodontology, Nagasaki University Graduate School of Biomedical Sciences, 1-7-1, Sakamoto, Nagasaki 852-8588 Japan

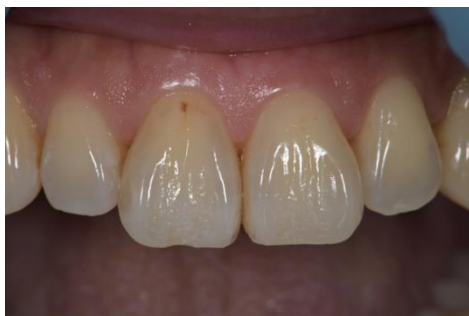
Fig.1

Figure 1. Caries and staining of the crack line on the labial surface of an anterior tooth. The stain was unable to be removed by dental prophylaxis and was thus suspected of extending into the enamel.

A 54-year-old female patient had an aesthetic issue concerning her maxillary right central incisor. Staining was observed at the crack line on the labial surface of the maxillary right central incisor, but no subjective symptoms or pain arising in response to thermal or evaporative stimuli were noted. The stain was unable to be removed by dental prophylaxis and was thus suspected of extending into the enamel (Figure 1). Based on the clinical evaluation, a diagnosis of cervical incipient caries was made for her maxillary right central incisor. Two treatment plans were suggested: (1) follow-up observation, or (2) composite resin restoration after removal of the caries and stain along the crack line. She expressed a preference for composite resin restoration.

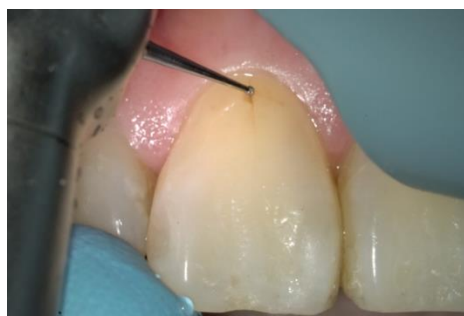
Fig.2

Figure 2. Removal of caries using a round bur. Caries was removed without anesthesia using a round bur with a high-speed air turbine and constant water cooling.

Caries was removed without anesthesia using a round bur (F-006-XLf; MARYDIA, Hinatawada, Ome, Tokyo, Japan) with a high-speed air turbine and constant water cooling (Figure 2). After caries removal, staining was observed along the crack line of the cavity floor (Figure 3). The stain was planned to be removed because it made aesthetic restoration difficult. Normally, rotary cutting instruments or laser instruments are used for caries removal; however, it is impossible to remove the stain from a crack line without damaging the intact enamel. Thus, in this case, a No. 12d scalpel blade (12d; Feather, Osaka, Japan) was used to remove the stain from the crack line (Figure 4). It was possible to remove the stain from the crack line in this manner without damaging the intact enamel because the

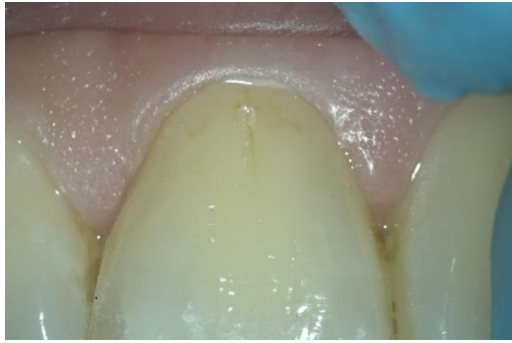
Fig.3

Figure 3. Crack line on the cavity floor. After caries removal, staining was observed in a crack line on the cavity floor.

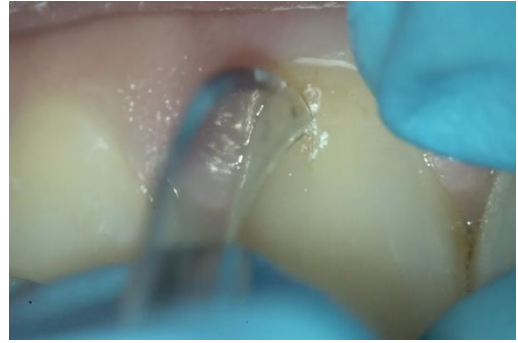
Fig.4

Figure 4. Removal of stain from crack using a No. 12d scalpel blade.

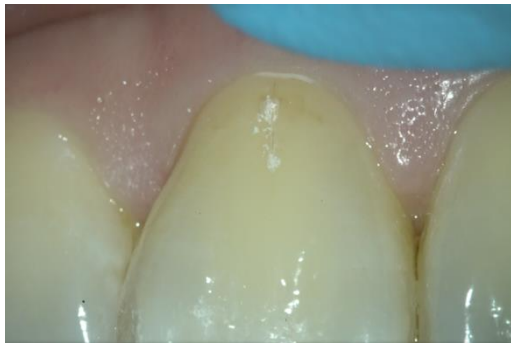
Fig.5

Figure 5. The stain had penetrated deeply into the crack line.

No. 12d scalpel blade is quite thin. After the removal of the stain (Figure 5), selective etching was performed for 20 seconds (Ultra-etch J; Ultradent, South Jordan, UT, USA), followed by washing and air-drying with a three-way syringe. After cotton roll isolation, an adhesive procedure was performed with a two-step self-etch adhesive (Clearfil Megabond II; Kuraray, Tokyo, Japan) according to the manufacturer’s instructions. The self-etching primer was applied, left for 20 seconds and dried with gentle air application. A bonding agent was then applied, dispersed with gentle air and light-cured for 10 seconds with an LED curing light in low-power mode (G-Light Prima II Plus; GC, Tokyo, Japan). The prepared crack was coated with a high-flow flowable composite (Clearfil Majesty ES Flow; Kuraray) (Figure 6), and the cavity was filled with a low-flow flowable composite (Clearfil Majesty ES Flow; Kuraray) using a thin instrument (Flowable art; Tokuyama Dental, Tokyo, Japan) (Figure 7). The composite resin was then light-cured for 10 seconds with an LED curing light (Figure 8). After filling, polishing was performed with Pogo (Polish go; Dentsply Sirona, Charlotte, NC, USA) (Figure 10 and 11). All procedures were performed under a dental operating microscope (OPMI Pico MORA; Carl Zeiss, Jena, Germany). The patient remained asymptomatic eight months after restoration (Figure 12).

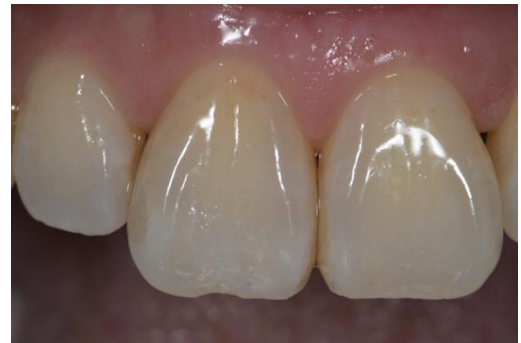
Fig.6

Figure 6. After removal of the stain from the crack line.

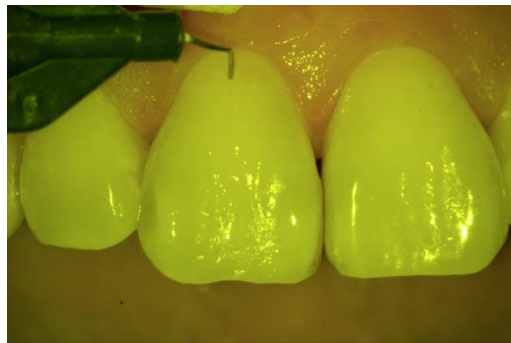
Fig.7

Figure 7. The prepared crack was coated with a high-flow flowable composite and filled with a low-flow flowable composite.

In the present case, caries and stains in crack under the caries were removed, the crack line was prepared, selective etching and adhesive treatment were performed according to the instructions, and the cavity was filled with a flowable resin composite. Because the cavity prepared with a No. 12 scalpel blade was thin and shallow, a flowable resin composite was adequate. Due to the risk of air bubbles being embedded when the low-flow flowable composite was injected into the thin cavity, a high-flow flowable composite was first coated onto the cavity floor of the microcrack using an instrument to avoid generating air bubbles. The low-flow flowable composite was then added and cured.

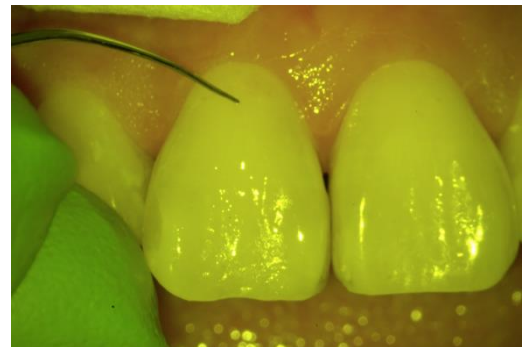
Fig.8

Figure 8. The morphology was adjusted using a thin instrument before curing with an LED curing light.

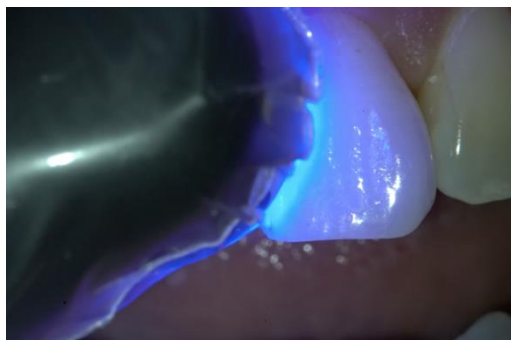
Fig.9

Figure 9. Filled composite resin was light-cured for 10 seconds with an LED curing light.

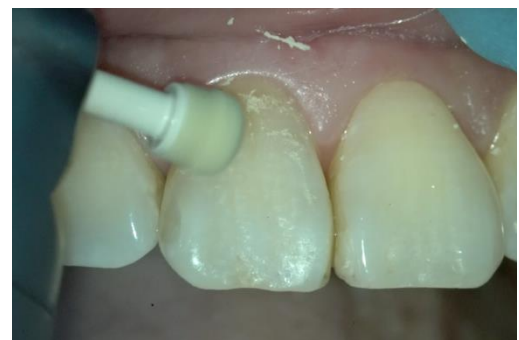
Fig.10

Figure 10. Polishing was performed with Pogo.

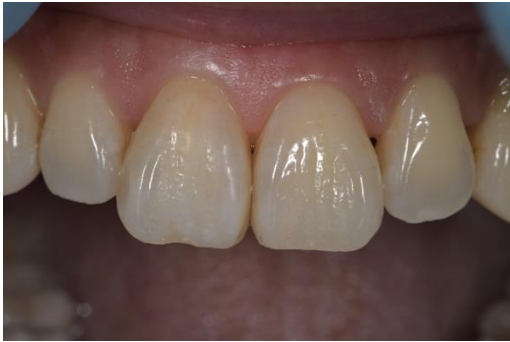
Fig.11

Figure 11. Post-restoration.

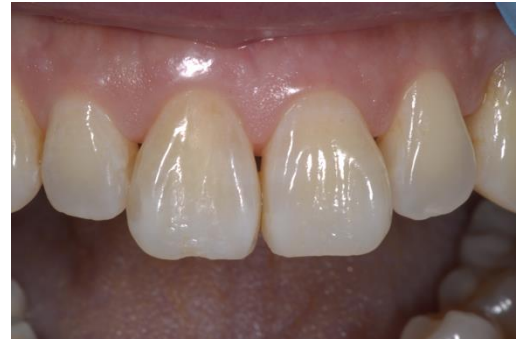
Fig.12

Figure 12. Eight months after restoration. The patient remained asymptomatic eight months after restoration.
